Analysis of the Relationship between Selected Ship and Propulsion System Characteristics and the Risk of Main Engine Turbocharger Explosion

Abstract: The scientific aim of this paper is to analyse the topicality of the turbocharger explosions and to attempt to answer the question of whether some technical characteristics of the engine can be perceived as directly connected with the risk of the turbocharger explosion. Moreover, our objective was also to calculate the turbocharger explosion probability. This article presents the results of a quantitative and qualitative analysis of 42 explosions of marine main engine turbochargers occurring between 1977 and 2022. The number of explosions was analysed, and the average and instantaneous frequencies of turbocharger explosions each year were determined. An analysis was performed of the number of explosions with respect to the age and type of ship on which the accident occurred. An analysis of the contribution of different types of main engine to the studied population of explosions was also carried out. Criteria such as the number of strokes, engine speed, type of crank-piston mechanism, cylinder arrangement, engine power per cylinder,

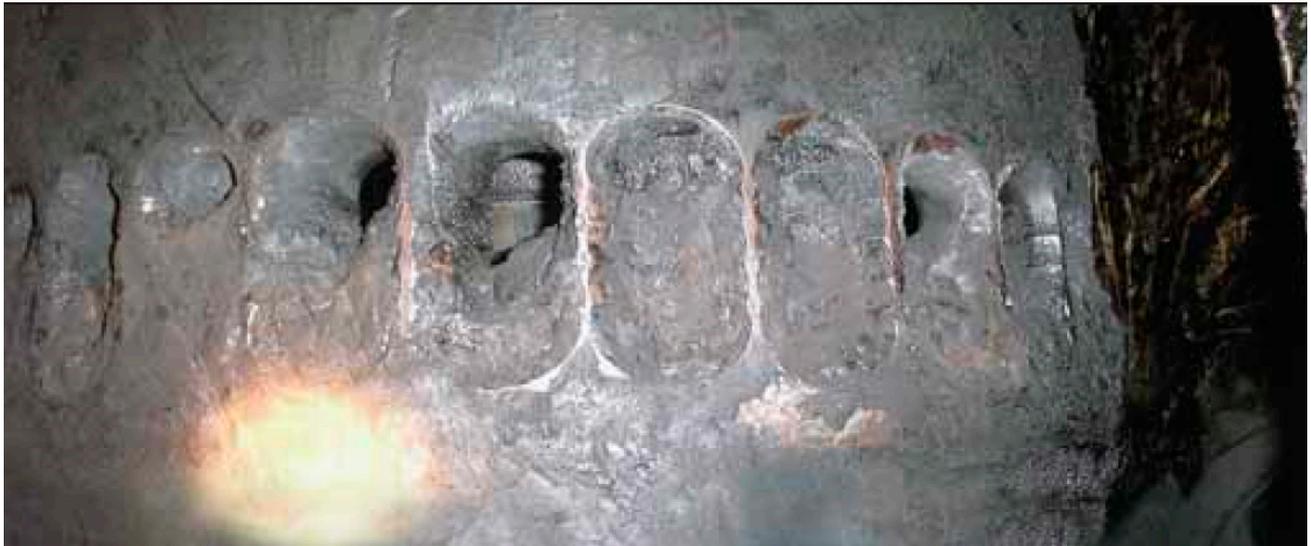
An analogous situation can occur with a lack of attention to the cleanliness of scavenging system components, including the cleanliness and permeability of air filters and coolers, scavenging spaces, under-piston spaces, and scavenging ports. An example of such negligence is shown in Figure 1, which shows scavenging ports with significantly reduced active cross-sections due to carbon deposits that had accumulated over a long period of time [20].

Figure 1. View of contaminated scavenging ports in the sleeve of cylinder No. 2 of the main engine of the m/v Goliath (Australian Transport Safety Bureau, 2006).

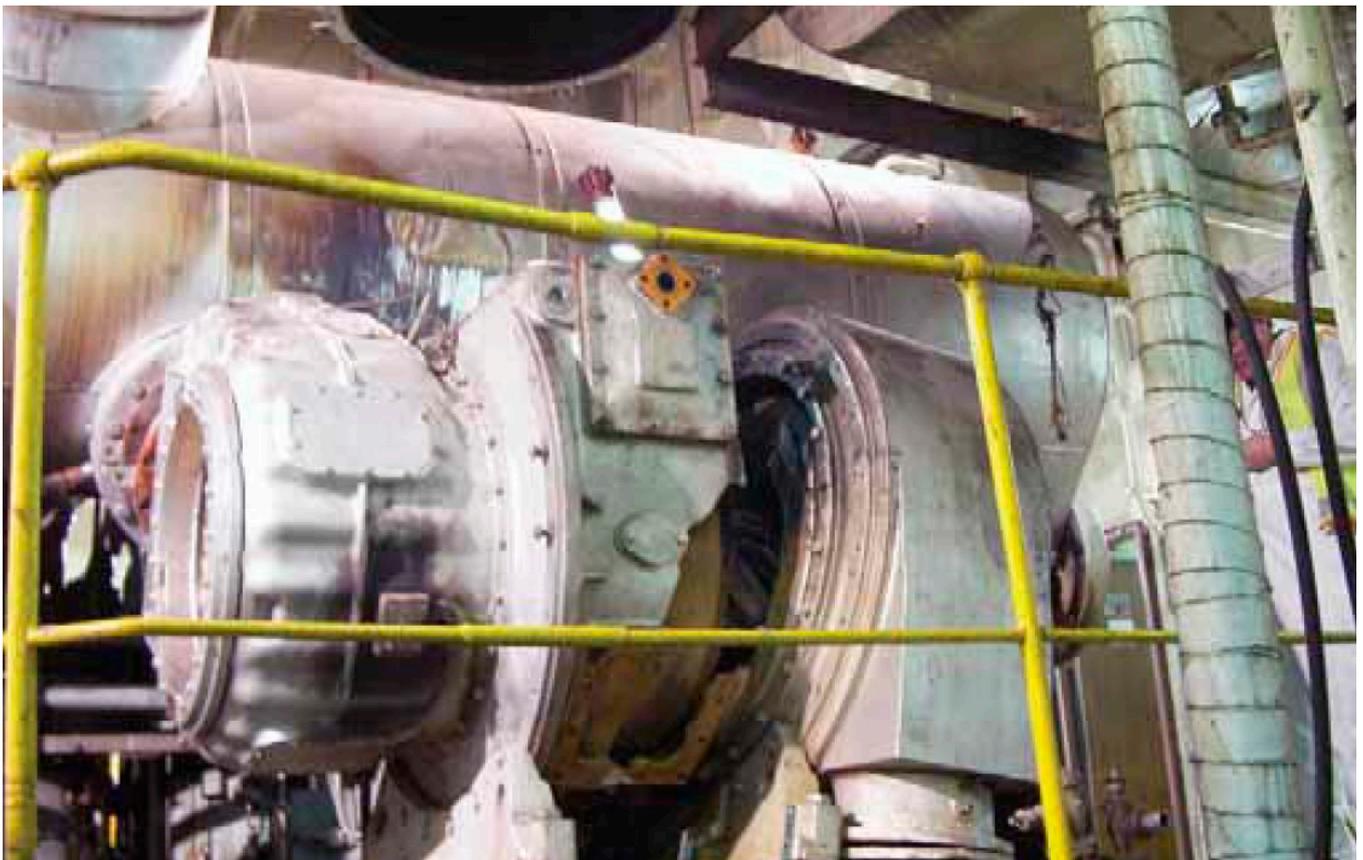
The replaced engine suffered two major failures related to turbocharger explosions on 22 September 2002 and 12 February 2003. The effects of these explosions are shown in Figures 2 and 3, respectively. Both explosions led to damage to the rotor and turbocharger body [20].

Figure 2. View of the turbocharger of the main engine of the ship m/v Goliath after the explosion on 22.09.2002 (Australian Transport Safety Bureau, 2006).

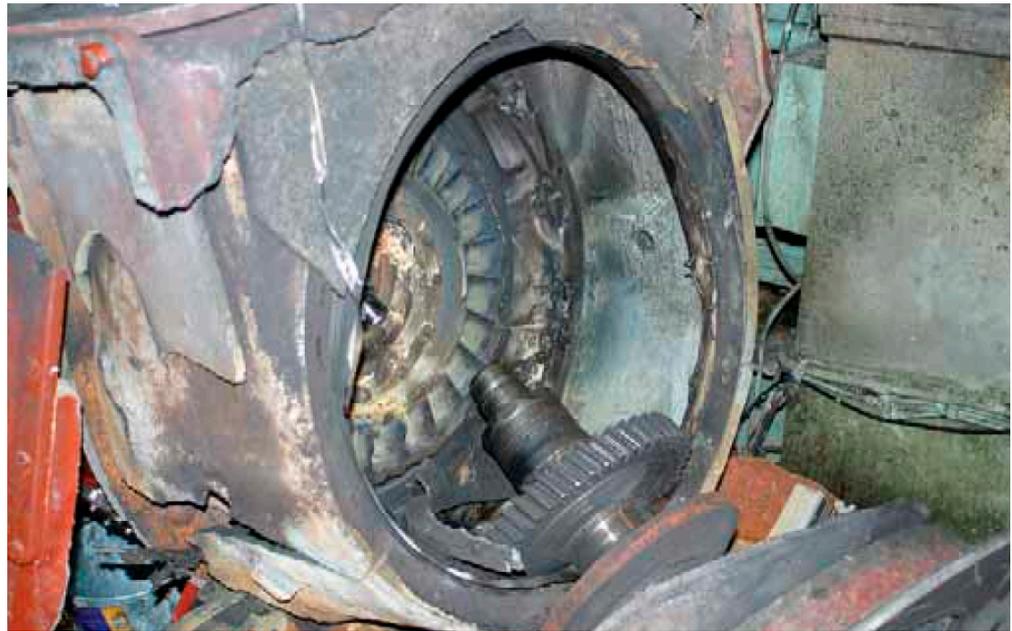
Figure 3. View of the turbocharger of the main engine of the ship m/v Goliath after the explosion on 12.02.2003 (Australian Transport Safety Bureau, 2006).
