# Engineering Failure Analysis

# Analysis of fuel properties in the context of the causes of three marine auxiliary engines failure – A case study

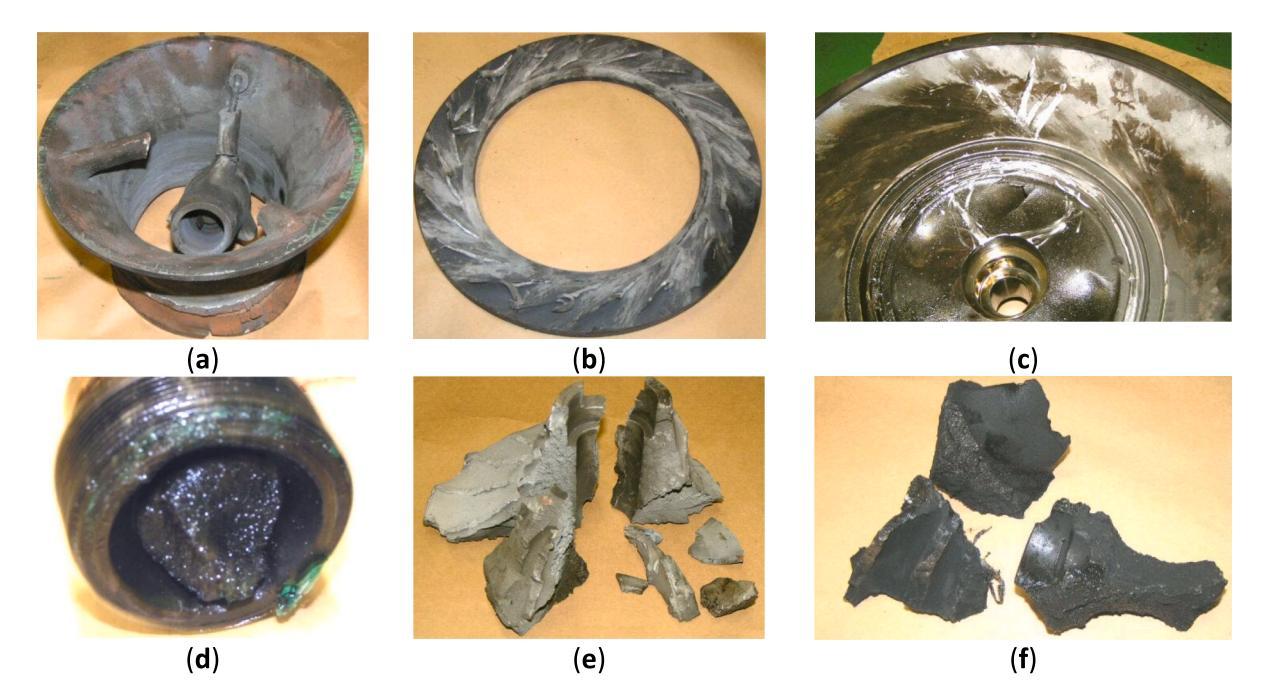
Fig. 1. Components of the turbocharger damaged because of its explosion: (a) exhaust gas inlet casing, (b) exhaust gas nozzle ring, (c) inside side cover, (d) twisted turbocharger shaft, (e) compressor rotor remnants, and (f) turbine wheel remnants.

The failure occurred due to a common cause [23–25], which was the negative impact of fuel on the engine components. During the power plant operation, three engines were damaged and stopped, and the turbocharger on one of the engines exploded – the view of the essential elements of the turbocharger after the explosion is shown in Fig. 1.

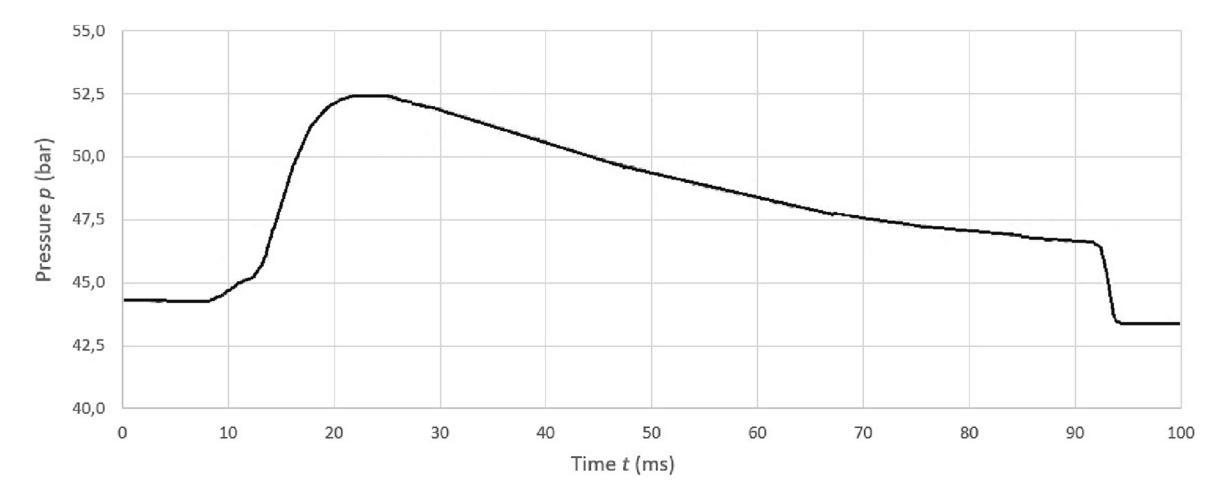
Fig. 3. Averaged pressure changes in the chamber of the FIA 100/3 apparatus during the ignitability tests of the tested fuel (modified from [14]).

Although the *CCAI* and *CII* values are normal, fuel ignitability tests performed with the FIA 100/3 apparatus clearly show that the tested fuel has very poor self-ignition properties. Thus, unburned fuel accumulates in the engine, which causes engine damage. When the accumulated fuel suddenly ignites, it causes fires in the exhaust manifold and air tank, which may lead to the explosion of the turbocharger. All these factors were at play in the present case of the severe accident in the ship's power plant.

The tested fuel had a much longer ignition delay *ID* and the period from fuel injection to the start of main combustion *SMC* was significantly longer than the average for residual fuels. However, the maximum value of the *ROHR* level, and its position on the time axis, are lower than the average. The summary of the laboratory fuel ignitability analysis is the *FIA CN* index, which in the present case is below the value of 18.7, that corresponds to very poor self-ignition parameters of the fuel and can cause serious problems when operating four-stroke engines at low loads, e.g., when a ship is manoeuvring into or out of a harbour.

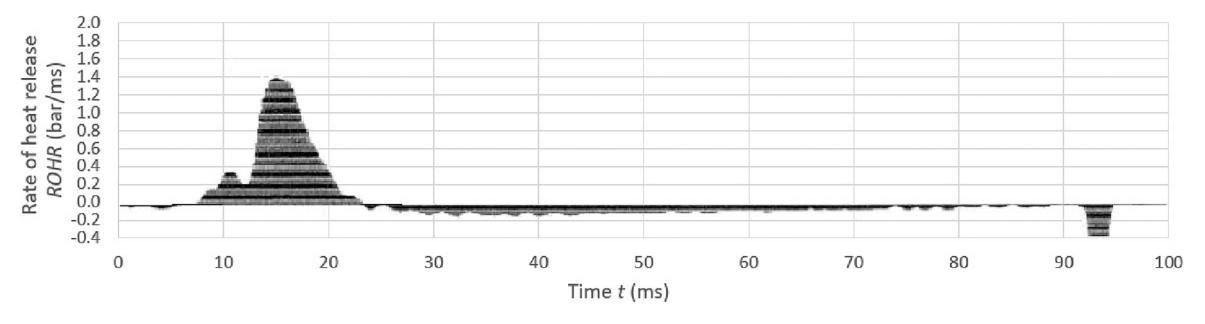
Fig. 4. Averaged change in the rate of heat release in the chamber of the FIA 100/3 apparatus during the ignitability tests of the tested fuel (modified from [14]).
