Assessing the Unreliability of Systems during the Early Operation Period of a Ship—A Case Study

Observations of failures were conducted during the first year of operation of a bulk cargo ship (Figure 2). The ship is a single-engine vessel built in 2011, with an unlimited cruising radius, five cargo bays, four cranes and a superstructure placed at its aft. The basic parameters of the ship are presented in Table 1.

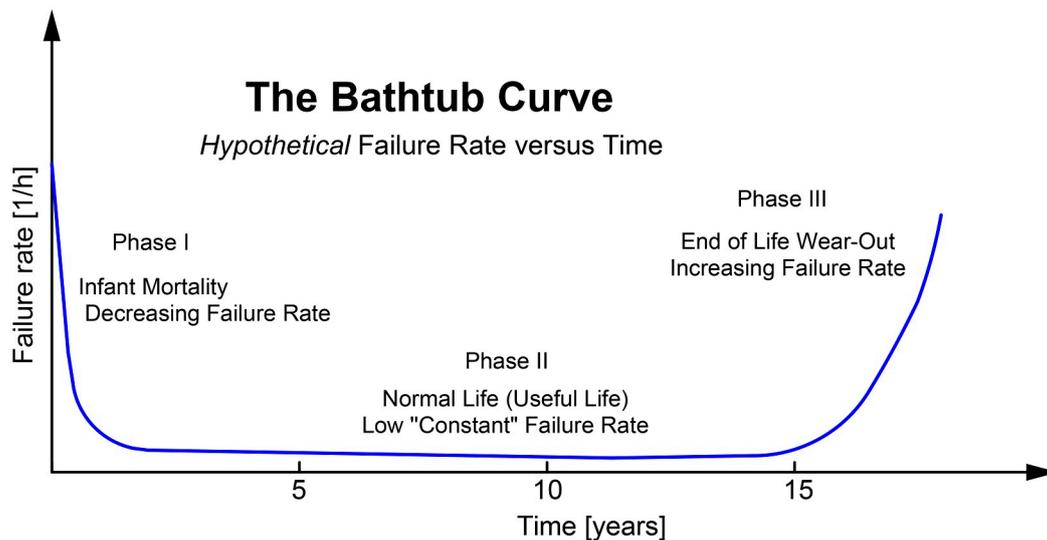
Figure 1. Plot of failure intensity λ of an object during its operation.

Therefore, to improve maritime safety, it is important to study the possibility of continuous improvements in reliability. The latter part of the paper presents cases of failures occurring during the first year of a ship's operation (Figure 1).

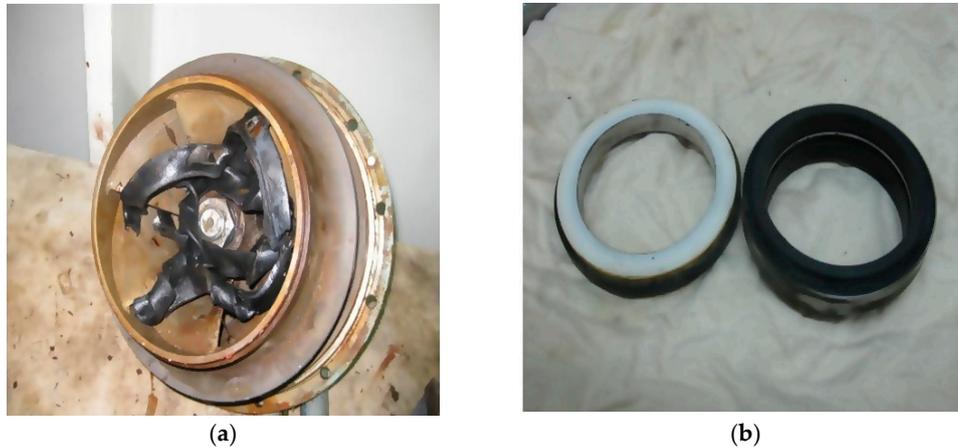
The failure of centrifugal pump no. 1 in the seawater cooling system occurred as a result of rubber reinforced with steel net entering the pump which was a leftover from the shipyard works. The rubber wrapped onto the pump rotor (Figure 3a), which translated the centre of gravity of the rotating components, causing intense vibrations and finally, the failure of the pump's mechanical seal (Figure 3b).

Figure 3. Failure of pump no. 1 in the seawater cooling system: (a) Primary cause of failure; (b) components of the failed patent mechanical seal.

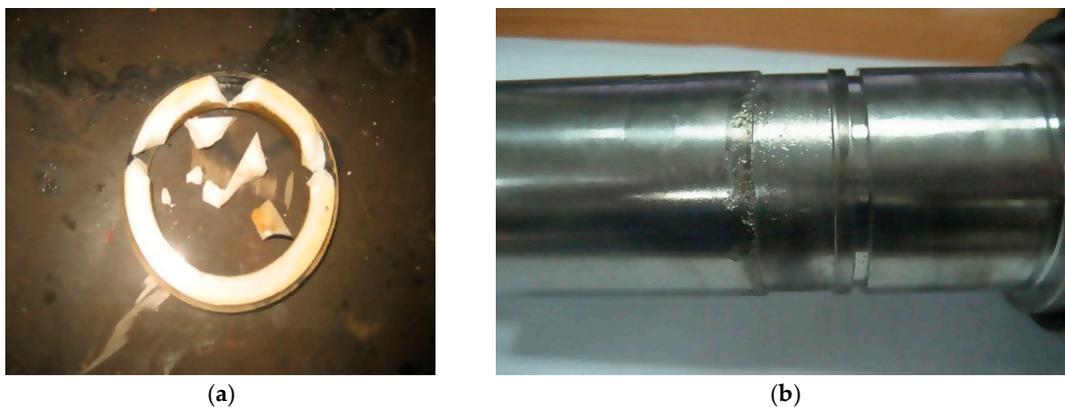
The failure of the mechanical seal of seawater pump no. 2 was related to the fracture of the sealing ring (Figure 4a). During repair, a secondary failure of the pump shaft was observed (Figure 4b).

Figure 4. Failure modes of pump no. 1 in the seawater cooling system: (a) Failed sealing ring, and (b) secondary failure of the pump shaft caused by abrasive wear.

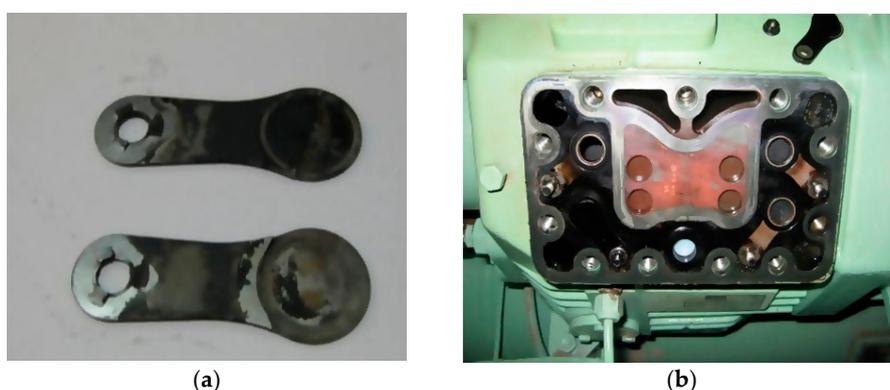
One of the general systems important for the proper operation of the ship is the refrigerating plane [20]. During the operation of the refrigerating plant, the refrigerating compressor no. 1 failed, which is a 4-cylinder piston compressor, working at a nominal rotational speed of 1740 rpm. The failure was related to the fracture of two pumping valves of the valve plate (Figure 5). Due to the malfunction, the electric motor of the compressor was overloaded, and the cylinder head overheated. The temperature increased due to the high pressure in the head, which led to a pumping out of the oil lubricating the cooling system compressor. To correct this failure, the valve plates of both cylinder sets were replaced.

Figure 5. Failure of the refrigerating compressor: (a) Fractured valve plates; (b) valve plate on the compressor.

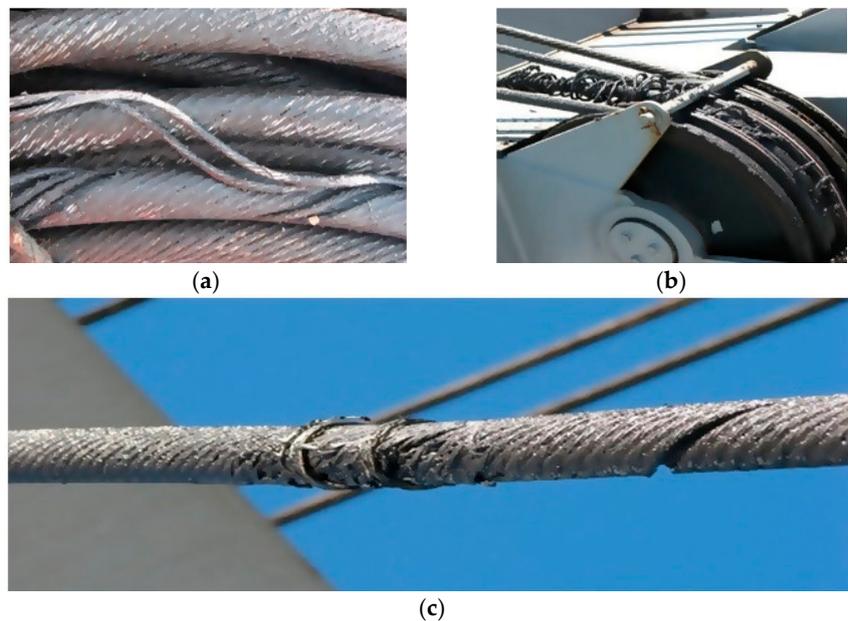
During a hydraulic-electric inspections of the cranes with a maximal load capacity of 35 t, it was found that in cranes nos. 1 and 3, the carrying ropes had fractured strands in different locations (Figure 6). Due to the low number of the total operating hours of the cranes, and the high cost of buying new ropes, the ship was visited by an expert sent by the ship’s owner to evaluate the situation. After surveying the ropes and the cranes and making measurements, the expert, along with the senior mechanic, did not find any reason for the rope breakage on the crane’s side. The cranes, along with the

whole tooling, were still under the warranty period by their producer, to which the documentation of failures was sent. In the nearest convenient port, the ship was visited by a service team from the producer, and after making their own inspections and measurements, they also did not find any defect in the crane. Error due to the crane operator was also ruled out, since the ropes could not have been damaged by incorrect operation.

Figure 6. Failures of the cranes' carrying ropes: (a,b) Crane no. 3; (c) crane no. 1.

The producer's inspection results indicated that the responsibility for the rope breakage, which was incorrectly made using low-quality materials, is on the side of the shipyard in which the ship was built. The failed ropes were replaced, and a spare rope was purchased. It was recommended that the ropes on the other two cranes be inspected twice as frequently.

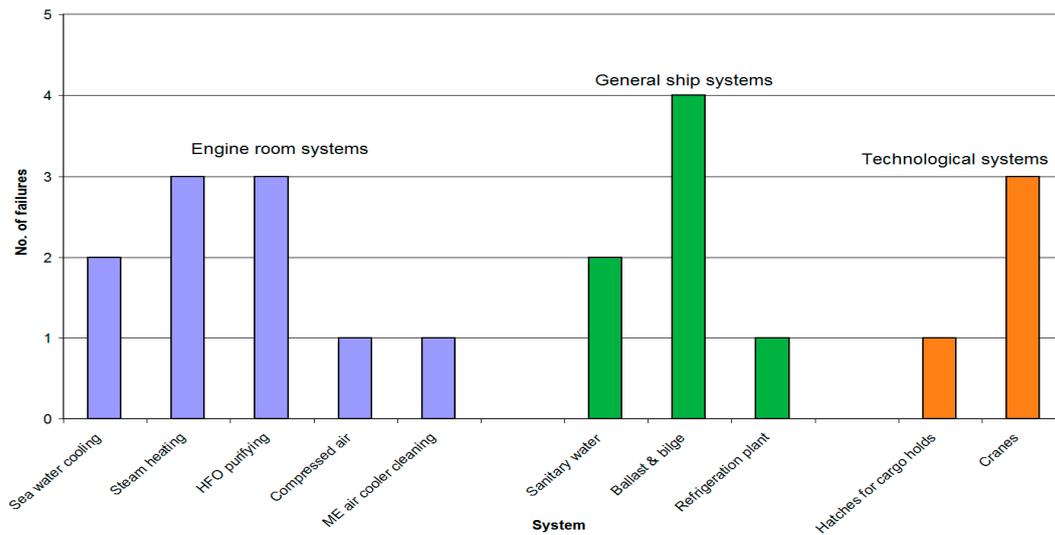
For the observed failures, statistics of susceptibility to failures were prepared. Moreover, based on the cause and effect analysis conducted on the ship and the available technical documentation, an attempt was made to categorise the particular failures. A quantitative presentation of failures in the particular systems is presented in Figure 7. Most failures occurred in the ballast-bilge system (4 failures) and in the steam heating, fuel cleaning and transshipment systems (3 failures in each system).

Figure 7. Number of failures amongst the analysed systems.

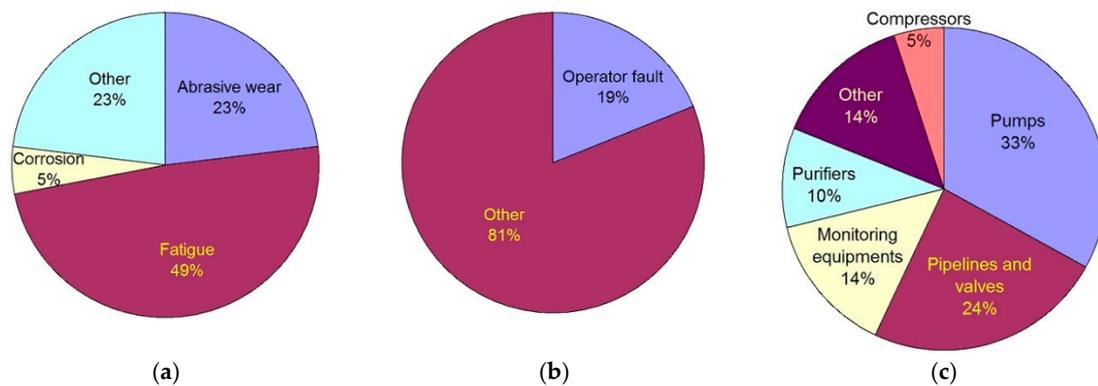
Figure 8a shows the percentage of failures divided by the type of wear, and Figure 8b shows the number of failures due to operator error. The dominant wear type was fatigue wear, which caused 49% of observed failures, followed by abrasive wear (23%), while corrosive wear accounted for 5%. The remaining 32% of failures were related to the operation of components under mechanical and/or thermal overload. Operator errors were a direct cause of 19% of the observed failures. Similarly, particular failures can be divided by the type of failed component. Such a division is presented in Figure 8c, which shows the most common failures were pump failures (33%), pipes and valve failures (24%), and monitoring equipment failures (14%).

Figure 8. Number of failures by: (a) Type of wear; (b) participation of the operator in the failure occurrence; and (c) component type.

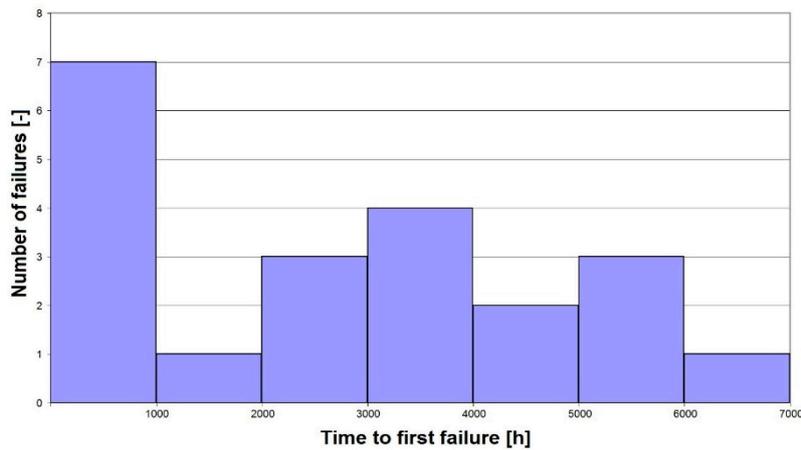
Because failures had been recorded since the ship’s launch (i.e., from the beginning of its operation), the observed moments of failures are also values of a specific reliability index—the time to first failure. Figure 9 presents the number of failures observed during 1000 h of the ship’s operation.

The distribution allows it to be concluded that most failures occurred in the first 1000 h of operation (7 failures, which accounted for more than 33% of all observed failures). These resulted from the mutual adjustment of components to specific operating conditions, which is a phenomenon known as running-in. It also confirmed the existence of an infant period in the operation process, during which the majority of material and technological defects in the system components appeared. After the first 1000 h, the failure intensity in subsequent 1000-h operating periods remained within the range of 0.001–0.004 h⁻¹.

Figure 9. Components’ number of failures as a function of mission time.

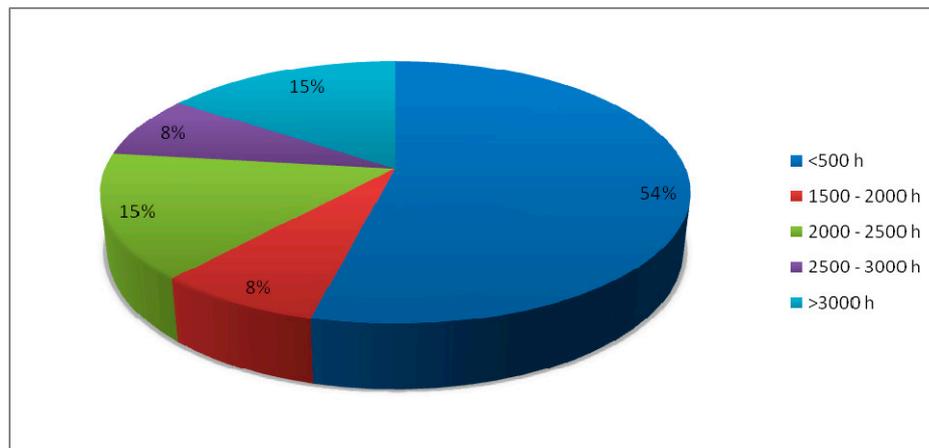
The pie chart in Figure 10 represents the percentage of failure modes relative to the number of hours the equipment has been operated. Out of the 13 failures observed in equipment that does not work continuously, as many as 7 (which constitutes 54% of the total failures in this type of equipment), performed for no more than five hundred hours. These problems could not be attributed merely to poor workmanship, or to the usage of improper materials during the production of the given elements. They likely also include errors during the assembly of previously-prepared parts and the improper handling of individual devices by the crew or operators.

Figure 10. Representation of the percentage of damage relative to the number of hours worked by the equipment.
